**Professional Engineer's Statement  
Everett Smelter Cleanup, 2000-2001**

# Washington Department of Ecology Everett Smelter Site 2000-2001 Cleanup

## Details of Cleanup Activities

Address: 2811 Medora Way  
Everett, WA 98201

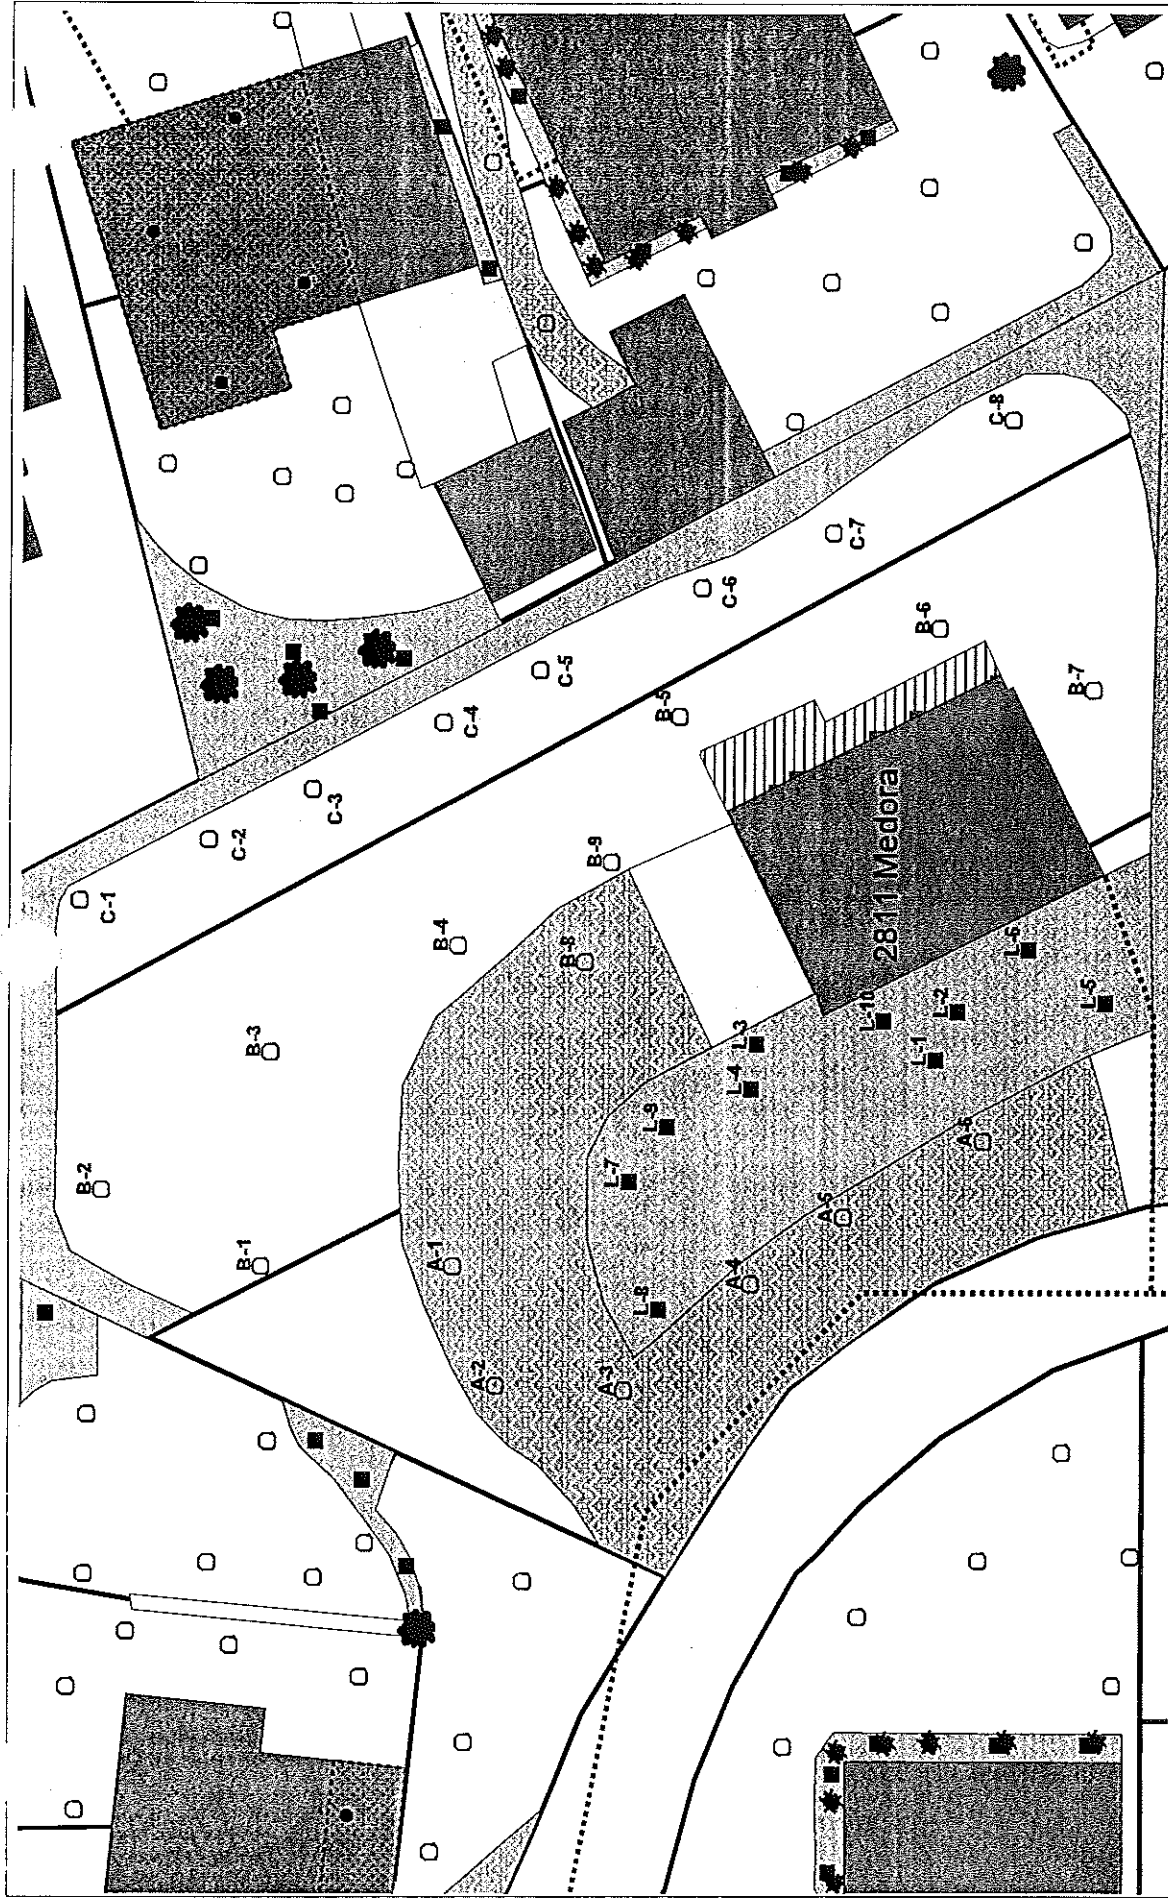
# 28111 Medora

This property was divided by Ecology into three Decision Units, A, B and C, as shown on the attached map, for purposes of pre-cleanup sampling and decision-making regarding the depth to which excavation was required. The following is a summary of the work done in the remediation of the property within each of the decision units.
